# **HABITAT CONDITIONS**

# **AQUATIC COMMUNITY CLASSIFICATION**

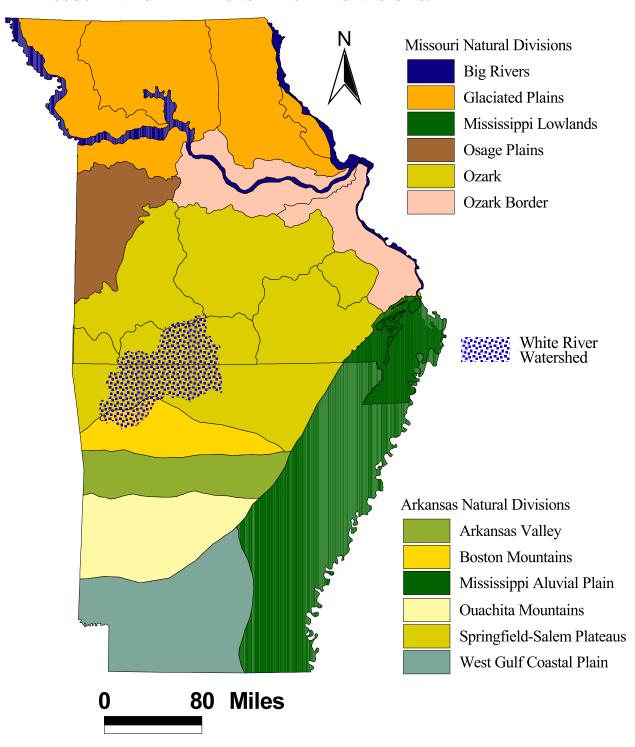
Figure HC01. The White River watershed's association to Missouri and Arkansas natural divisions.

The portion of the White River covered in this document is part of the Ozark-White Division community, a portion of the larger Ozark Aquatic Faunal Region (Pflieger 1989). Streams in this classification are found in narrow, steep-sided valleys with high bluffs and are characterized by high gradient and relief (usually between 300 and 600 feet). Streams are clear with a substrate of mostly gravel and rubble with some bedrock. Channels have clear, well-defined riffles and pools. There are numerous springs in the area due to the karst topography. This makes some streams of the region ideal for coldwater fisheries (Pflieger 1989). The watershed is located entirely within the White River Natural Division in Missouri (Figure HC01).
